1 Pace Plaza East Renovation - Progress Photos

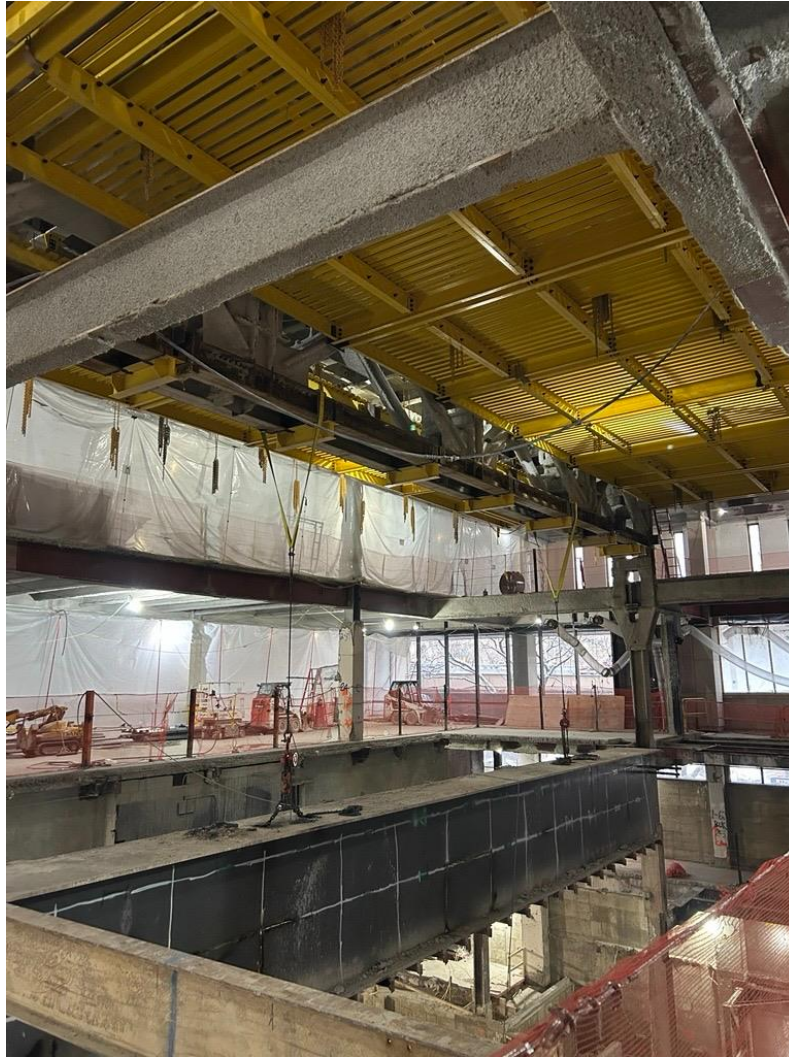
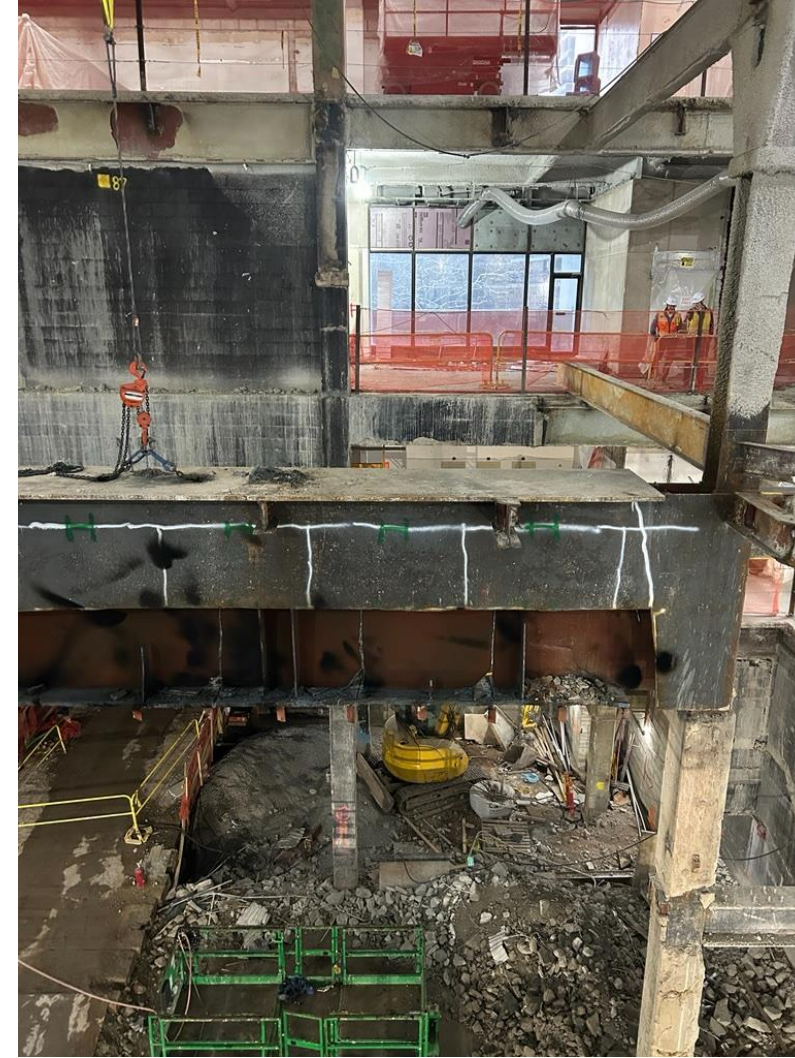
Progression of structural steel demolition at the Large Venue.

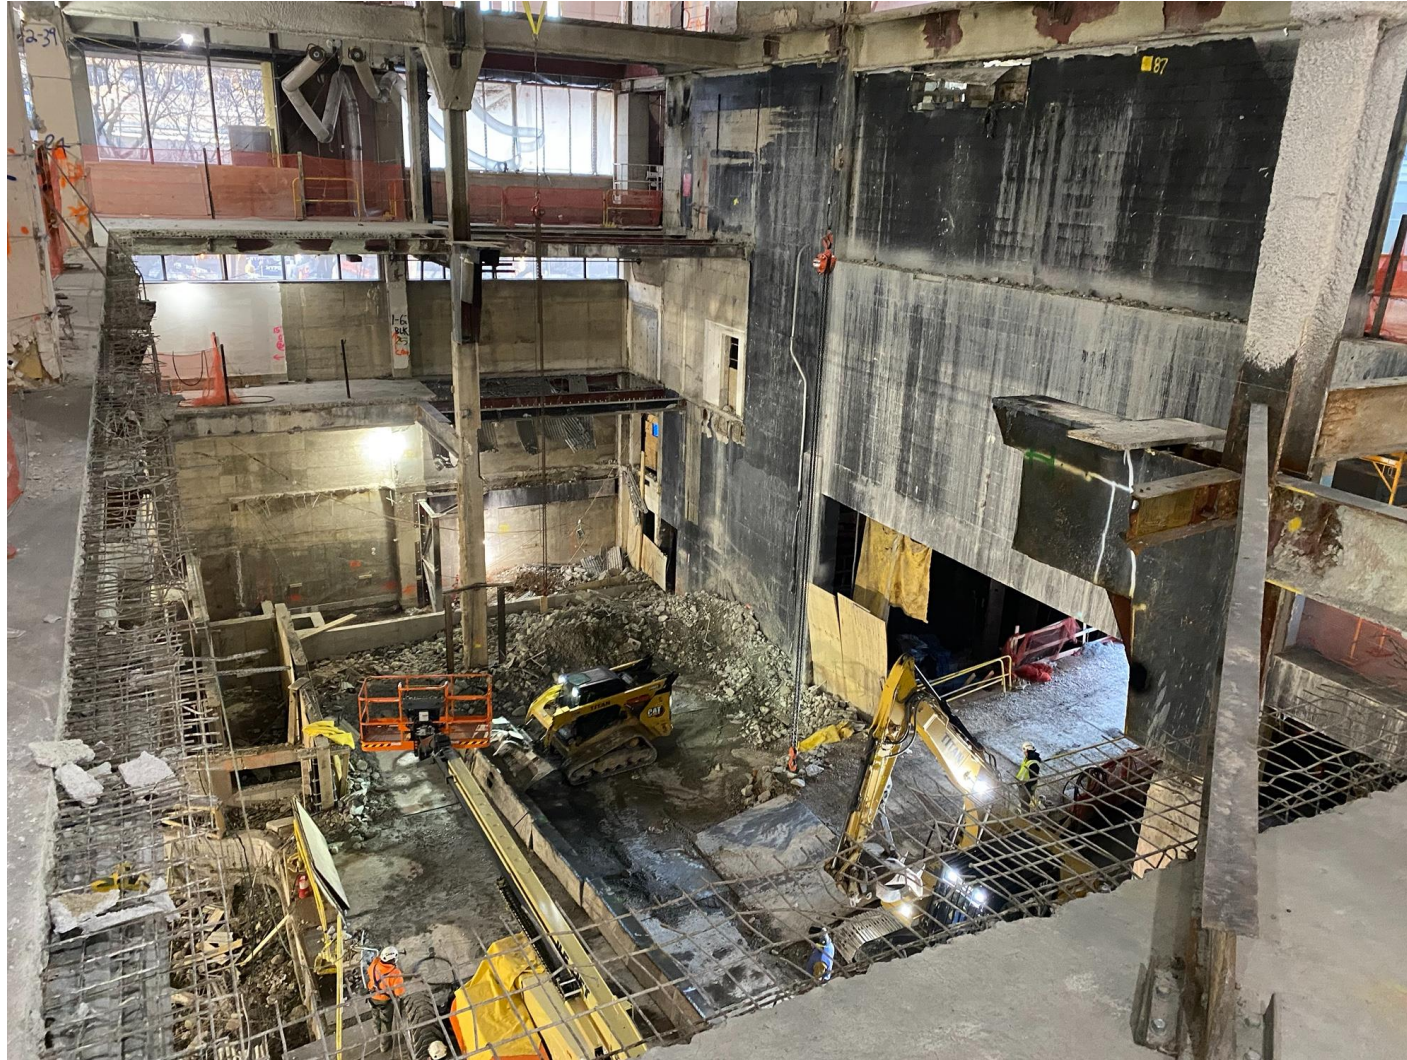
Large Venue girder truss has been completely demolished.

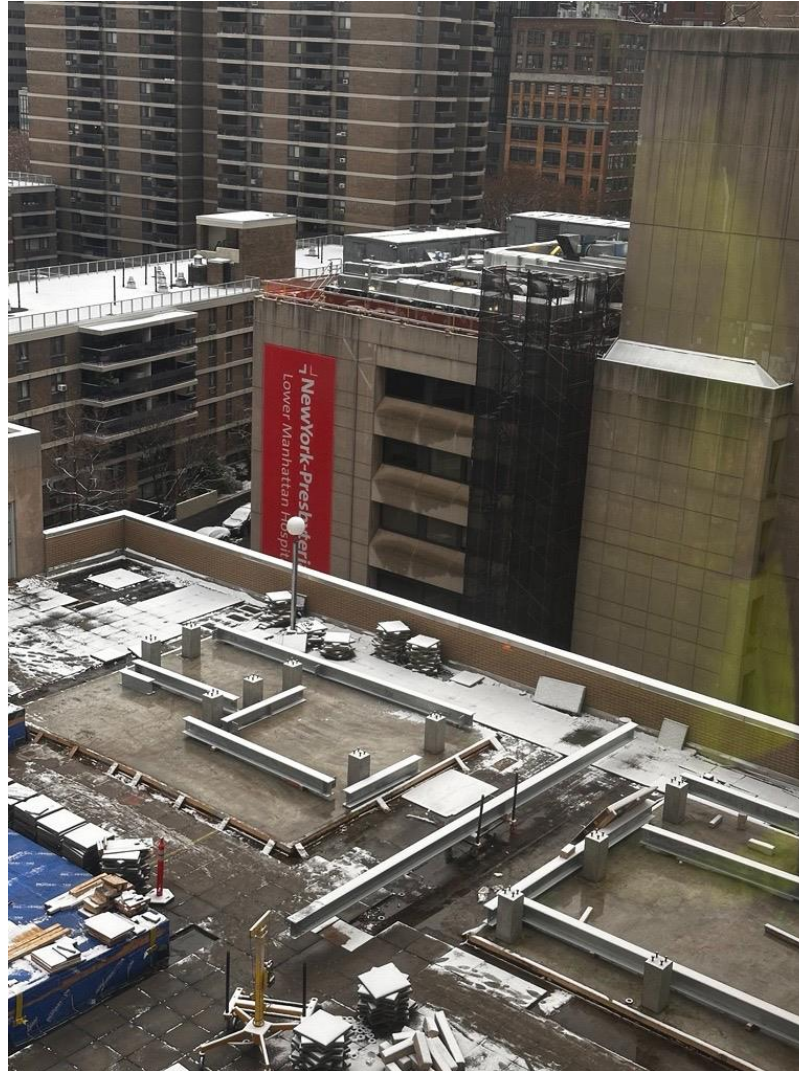
New steel dunnage for outdoor mechanical units has arrived on 4th floor roof.

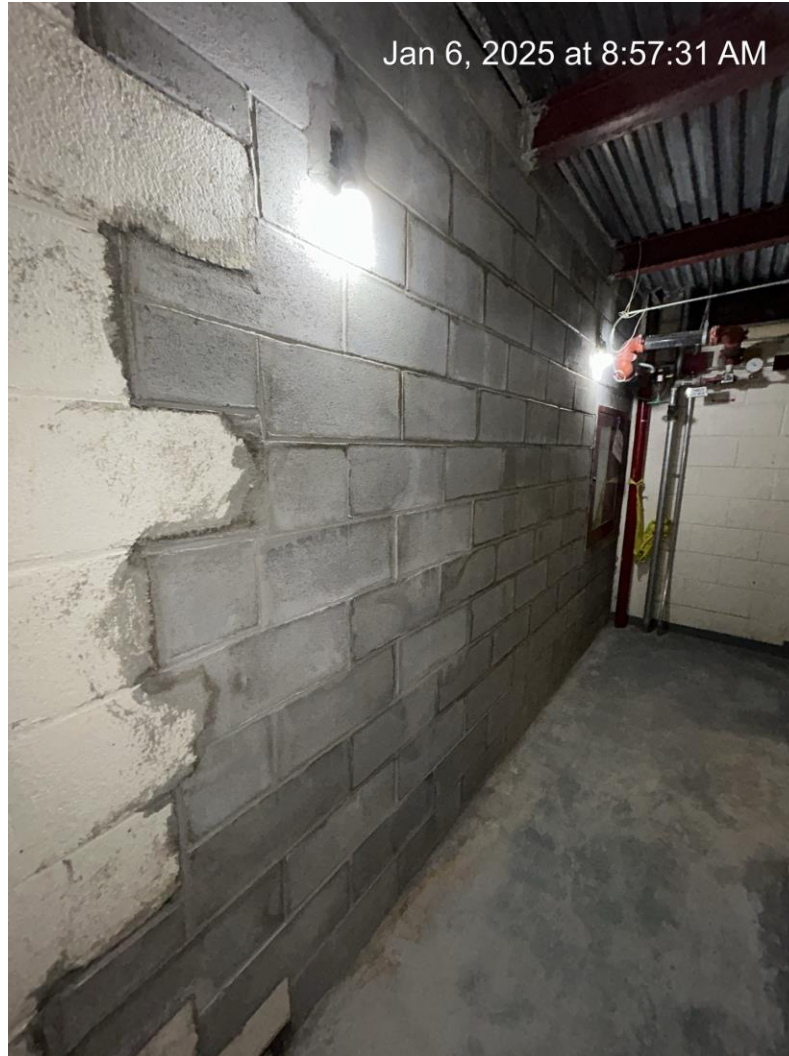
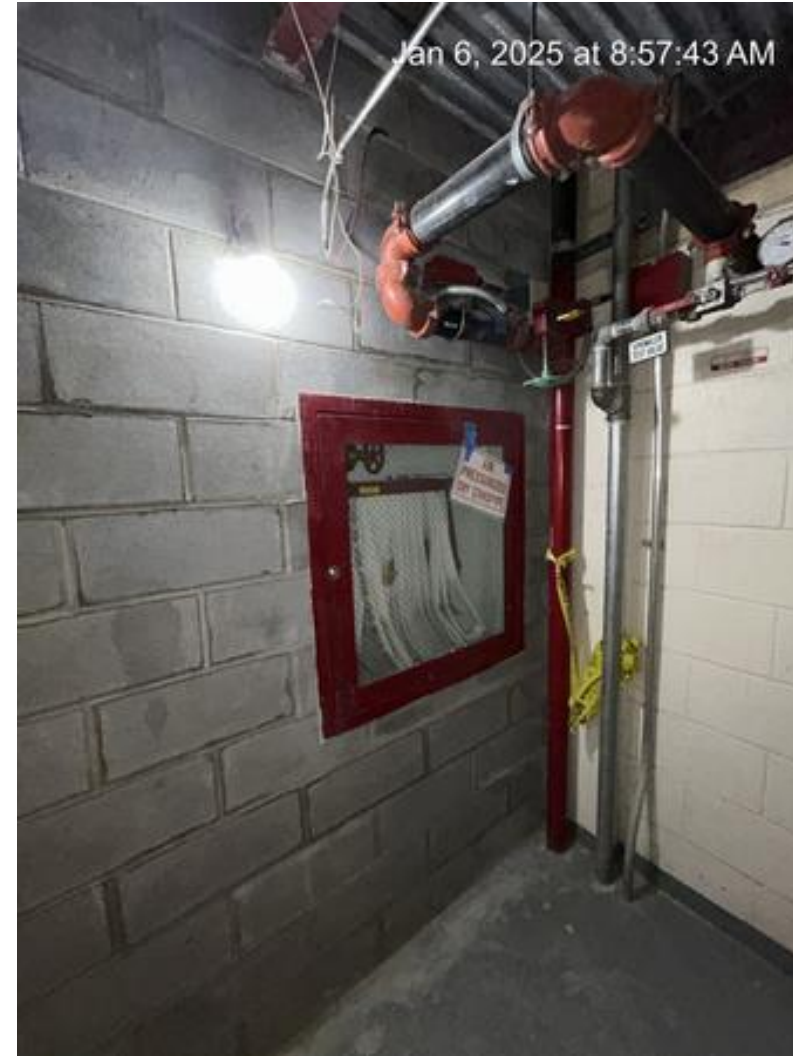
CMU wall remediation in Maria's Tower stairwell.

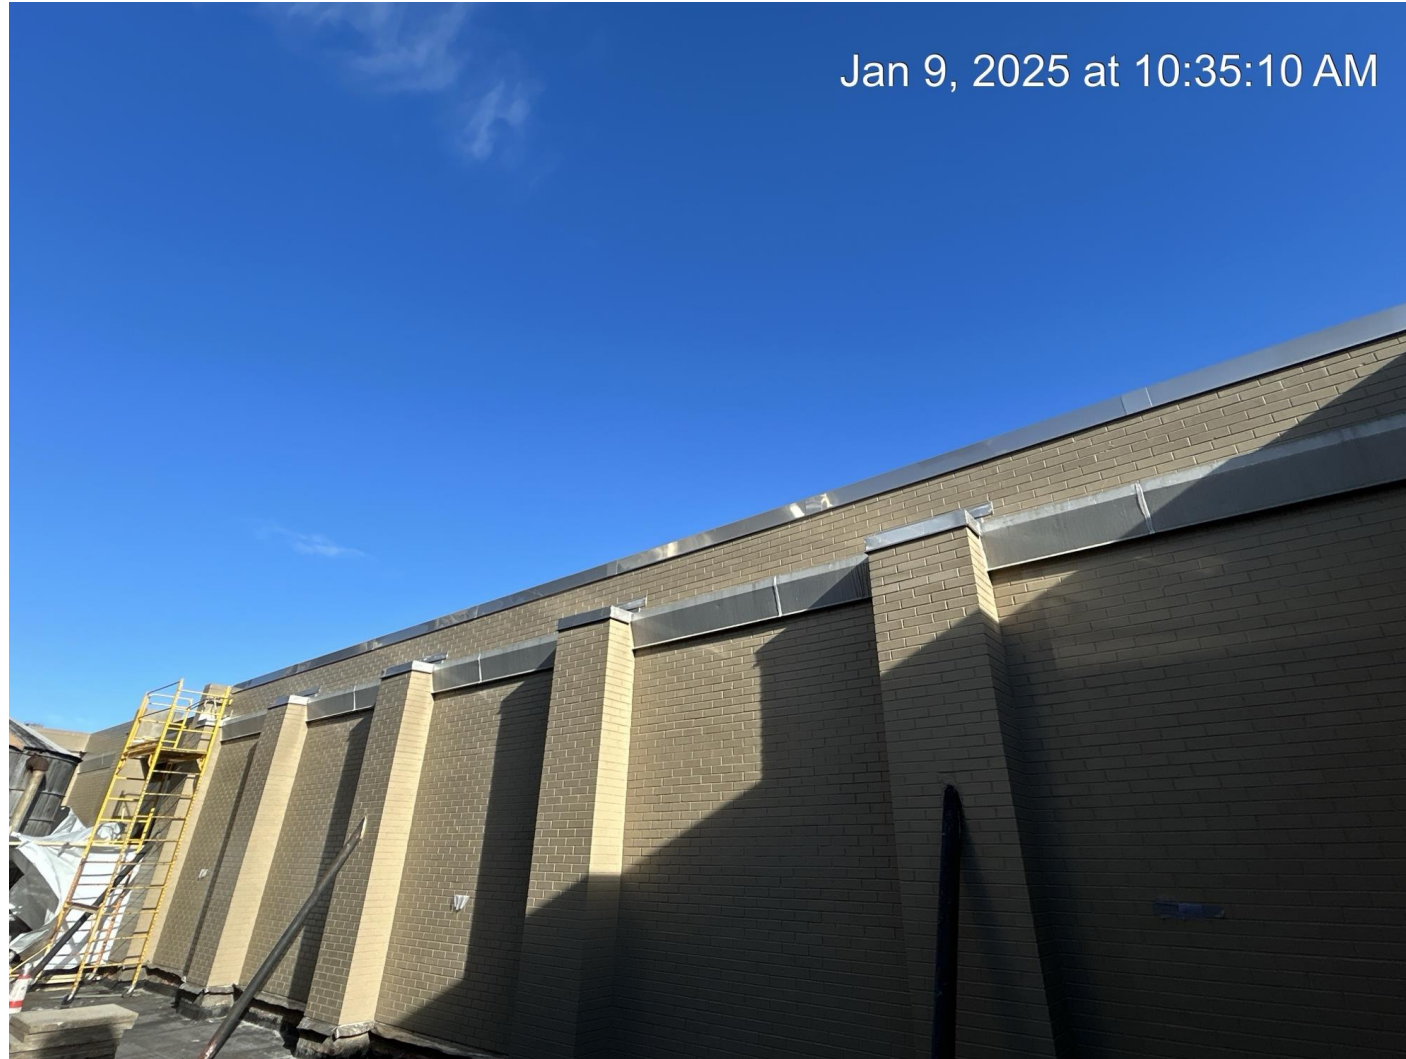
Waterproof coating and new coping installed to the existing Maria's Tower parapet walls.
